Technical Bulletin

Subject: Door, Squeaking Noise in Latch/Lock Area

Number: 00-02

Model(s): New Beetle

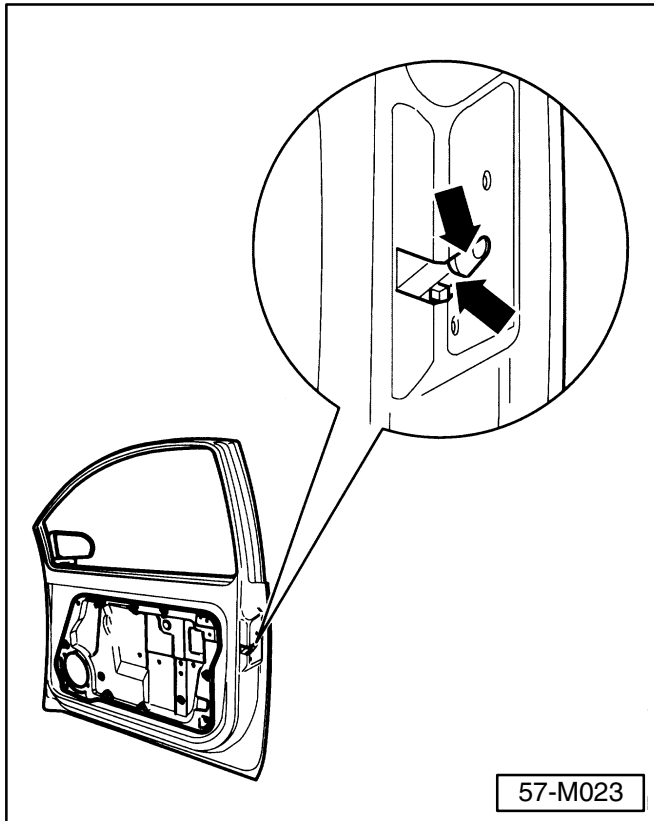
Squeaking noise in area of front door latch/lock area.

May be caused by lack of lubrication at door latch contact surface over time.

- Open doors.
- Thoroughly clean door locks with clean cloth.
- ◀ - Lubricate door locks at -arrows- using silicone spray Part No: D 007 000 A2 in short bursts.
- Close and open doors several times.
- Inspect sprayed areas -arrows- (they must be damp with silicone spray), reapply if necessary.
