# Technical Bulletin

Subject: **Wiper Blades, Skipping**

Number: **95-03**

Model(s): **Golf, GTI, Jetta**

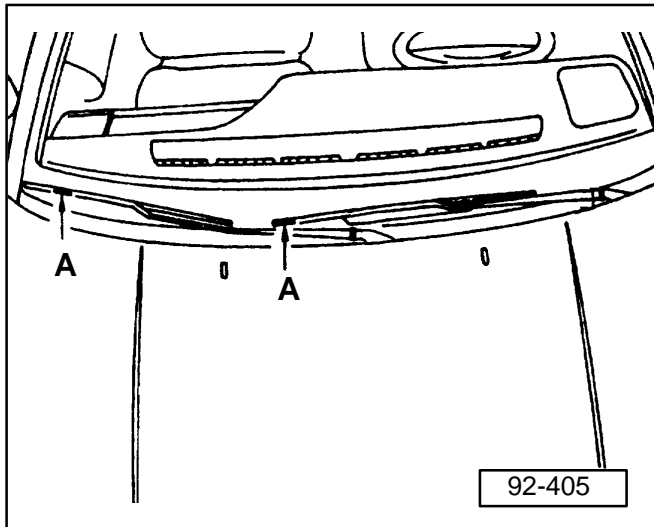
Complaint of windshield wipers jerking or skipping across the windshield can be caused by an incorrect contact angle of the wiper arms.

- ◀ – Set wiper arms to rest position.
- Loosen wiper arms and adjust blades to markings **-A-** on windshield.
- Tighten wiper arms.
- Remove wiper blade.
- ◀ – Insert wiper arm **-2-** into wiper arm adjustment tool 3358 and secure with retaining bolt **-3-**.
- Apply 24 mm wrench **-1-** to the adjustment tool and twist **-arrows-** wiper arm **-2-** until the correct angle is attained according to the table below.
- Loosen retaining bolt **-3-**, remove wiper arm **-2-** from adjustment tool then reinstall and recheck.
- Check setting using table on page 2. If necessary, the setting and checking procedure should be repeated until specified value is attained.

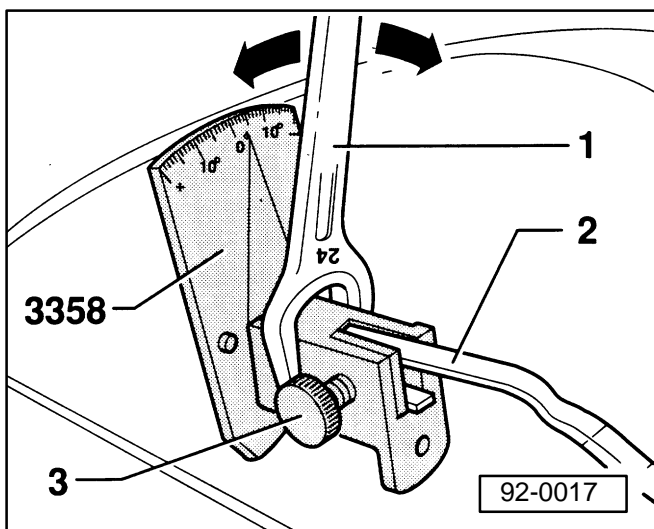
Wiper arm contact angle	
Driver side	0°/*-3°
Passenger side	0°
Rear wiper	+3°
Tolerance	±2°
